## Cypress In-Line Inspection Municipal Water Aqueduct

### Extra-High Resolution Magnetic Flux Leakage (MFL) In-Line Inspection of Mortar-line Steel Aqueduct for Denver Water

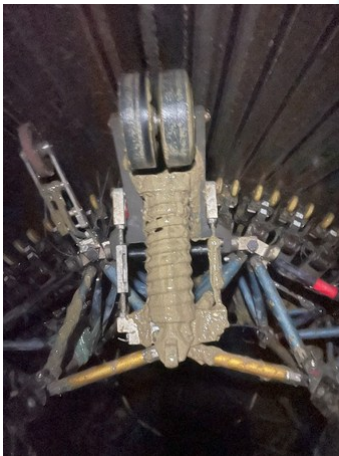
During the walk through of the pipeline prior to the inspection, Cypress ILI personnel noted that the pipe appeared to be oblate, wider side to side than top to bottom. If a pipeline has been deformed over time, the MFL tool has a more difficult time moving through the line. Additionally, the pipeline had a biofilm on the pipe surface which reduced traction of the ETVs significantly during the inspection process. The MFL is designed with collapsible magnetic sections allowing it to move through varying changes in the diameter of the pipe including changes in the shape of the pipe. However, in this case, the combination of height-to-width disparity and poor ETV traction caused the tool to become stuck at a welded joint.

The biofilm, which caused traction problems, was scraped off of the wall and collected on the tool. The collected material is shown on a support spring.

With the tool stuck at the weld, the field crew contacted Cypress ILI's mechanical engineer in Salt Lake City to discuss a solution. It was determined that the best approach to complete the inspection was to remove one section from the tool and collapse the remaining sections to create a smaller version of the tool. The field crew successfully executed this adjustment in under two working days.

The inspection resumed from the point where the MFL had been stuck, but the biofilm on the pipe surface continued to hinder traction for the ETVs. Despite this challenge, the field crew persevered and completed the inspection. Upon completion, the tool and the ETVs were extracted from the pipeline by disassembling it into smaller sections and passing the sections through a side mounted manhole.
