In-Line Inspection

## City of Denver 72" Coal Tar Lined Potable Water Aqueduct

### Extra-High Resolution Magnetic Flux Leakage (MFL) In-Line Inspection of Mortar-line Steel Aqueduct for Denver Water

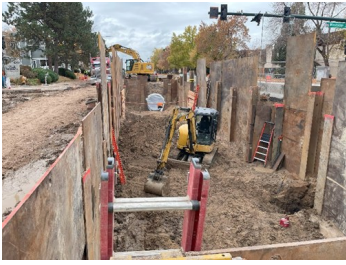
Work area showing the opening where the tool was inserted into the pipeline.

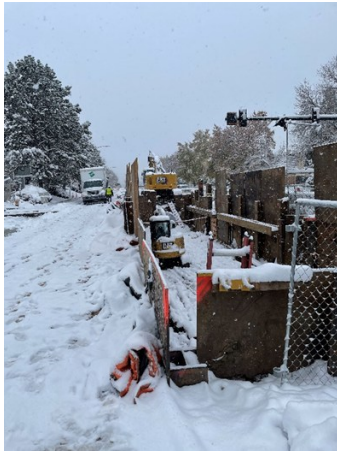
Weather was a problem at times.

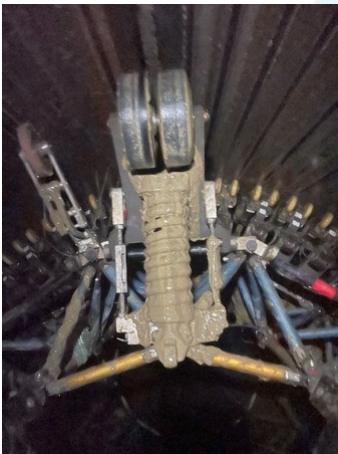
The biofilm, which caused traction problems, was scraped off of the wall and collected on the tool. The collected material is shown on a support spring. The biofilm does not affect the inspection data.
