## UHR Inspection of 6" 1953 Natural Gas Pipeline in Pottstown, PA near Schuylkill River in Montgomery County, PA – Top 5 Pipeline Operator

- Cypress ILI trial run for Top 5 pipeline operator. The line was last inspected by Rosen with legacy technology
- Customer desired UHR Data on their pipeline to compare Cypress with prior vendor and another UHR competitor.

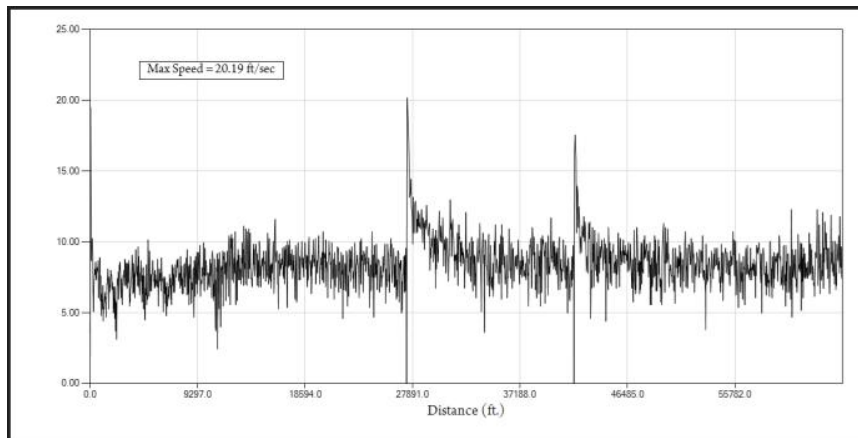
Figure 1 - Tool Velocity Graph

The flow rate was interrupted twice with the tool stopping and as pressure built back up it hit 13.6 MPH and 11.6 MPH and still both magnetized the pipe and captured data as the result of the Cypress electrical architecture and magnet design. The tool also experienced a hard stop at a lateral that had enough force to push the tool backwards.

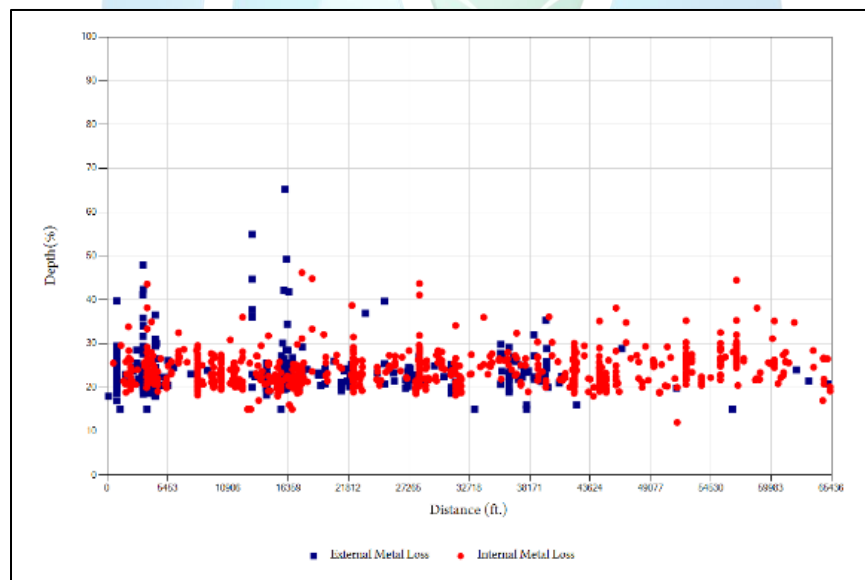
Figure 3 - Anomaly Distribution

Our UHR tool collected over 61 GB of data. Our DA team of experts identified > 1,100 anomalies and > 155 clusters with our UHR technology. We identified nine anomalies > 40%, several pinholes, and one dent with metal loss on top of pipe. Competitor tools failed to identify a significant dent gouge with metal loss. The customer elected to perform an expensive dig to verify. Cypress was spot on and well within spec. The other two competitors missed this important threat.
