# Proactive Integrity Management for PCCP

## Magnetic Flux Leakage Inspection

### PCCP Assessment

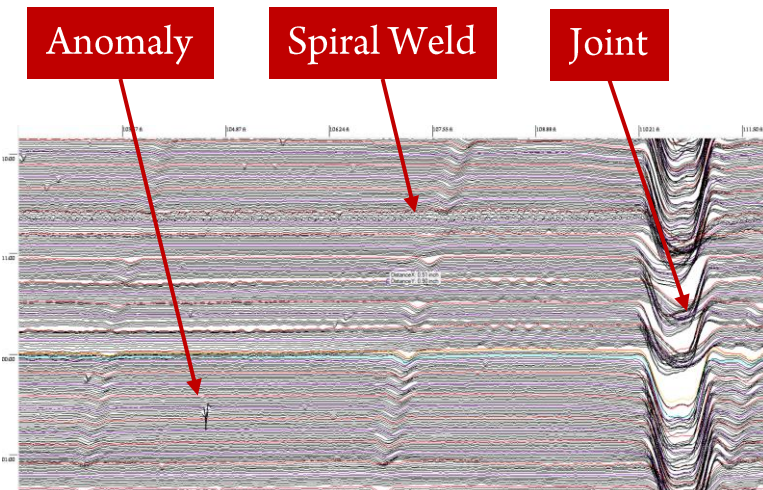
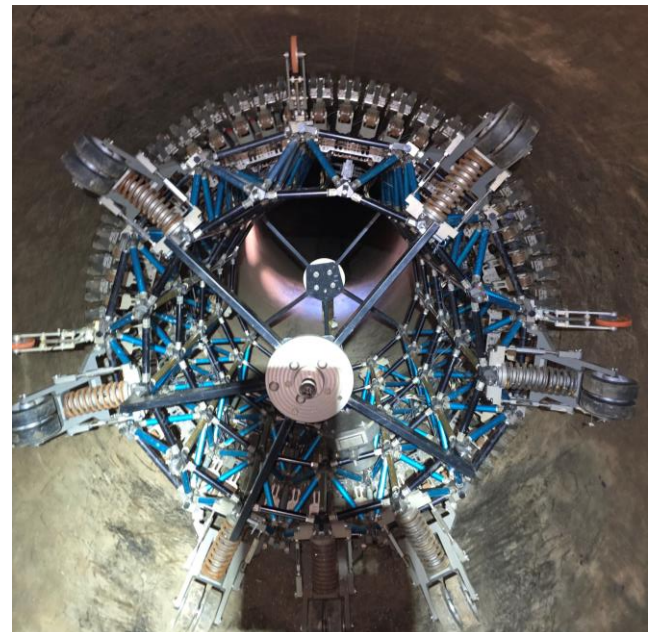
- High resolution sensor spacing (1/4”) and high-- speed sampling frequency (1400 Hz)
- Size configurations ranging from 48” to 144”
- Inspection through internal linings over 1” thick with greater capability in custom magnetizer configurations
- Tool can be installed through access points as small as 16” diameter
