CYPRESS
In-Line Inspection

EcoVision™ Extra High Resolution MFL Condition Assessment

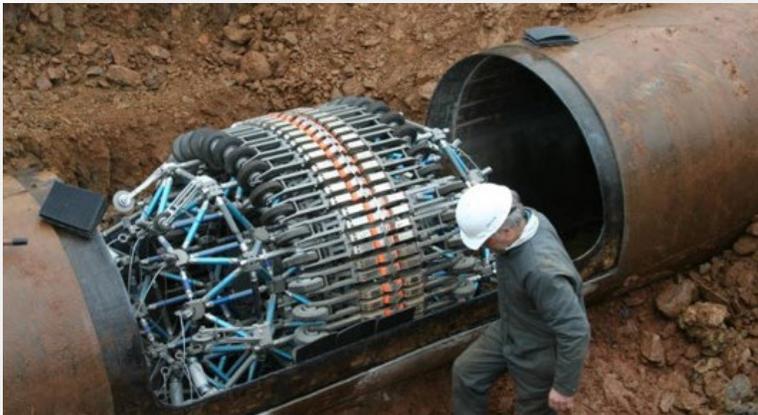
MFL is a magnetic method of non-destructive testing that is used to detect corrosion and pitting in steel structures and is commonly used in oil & gas pipelines. The basic principle is that an In-Line Inspection (ILI) tool with a circumferential array of powerful dipole magnets is displaced (in this case pulled) through the inside of the pipeline magnetizing the steel. Hall-Effect (magnetic field strength) sensors are positioned between the poles of the magnets to detect pipe anomalies.

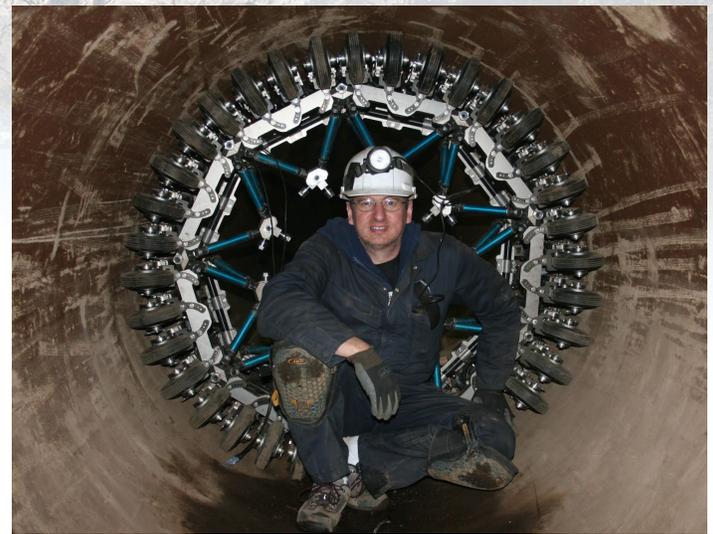
As the tool travels down the line the magnets fully saturate the pipe wall. If that magnetic field remains constant (does not fluctuate) there is no corrosion. If there is fluctuation, an anomaly is located at that point. All this data on the condition of the pipeline is stored, and upon completion of the run is download to Cypress ILI's proprietary software used to size the defects.

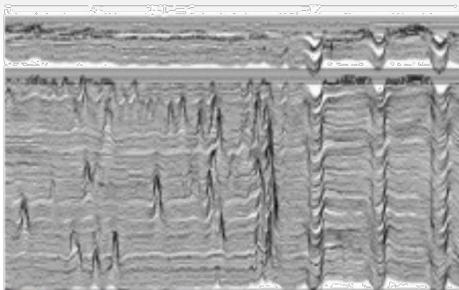
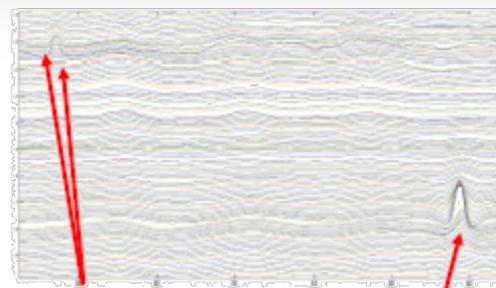
MFL Tool Data:

Deeply pitted section of pipe adjacent to three stiffener rings.

54% & 44%
Pit Depth

90% Pit Depth

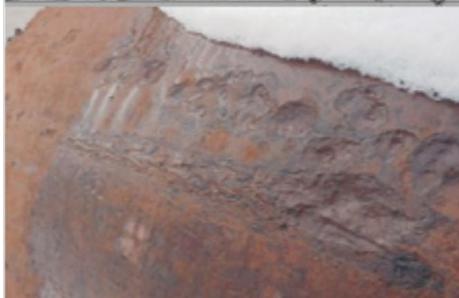
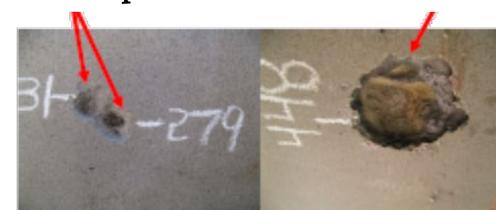
In-Ditch Verification Results:

Deeply pitted section of pipe adjacent to three stiffener rings.

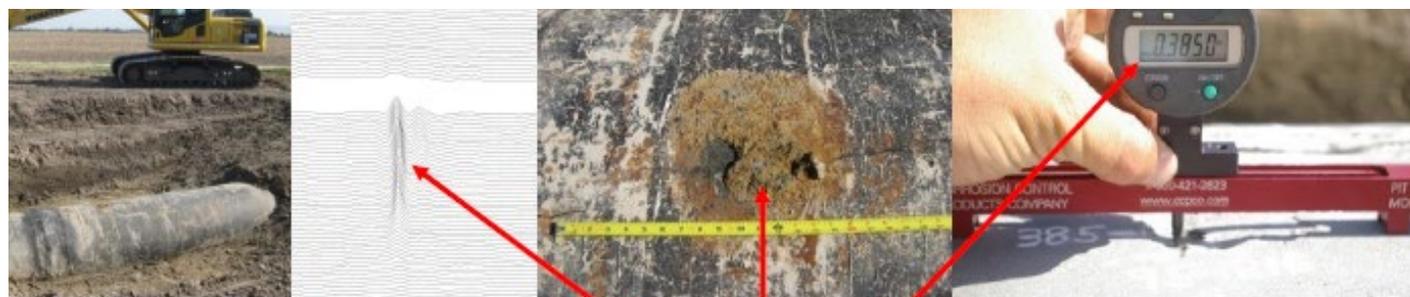
Pipeline Damage by 3rd Party:

The images below demonstrate the data analysis of an anomaly detected during the condition assessment of a mortar-lined large diameter pipeline. By exposing the pipe during this in-ditch verification activity, the anomaly length, depth, and width was validated against the extra high resolution MFL tool. This damage, was in fact a gouge, was likely caused by a farming plow and was not detectable by any other means. With the high potential of resulting in a leak or rupture, the damaged section was replaced. Cypress ILI can also run a “caliper” tool through the line prior to the MFL operation to record any dents, ovalities, coating damage, and/or any other restrictions that would impede flow rates or safe MFL tool passage in the pipeline.

70% Pit Depth
