# North Jersey District Water Supply Commission

CASE STUDY

## Cypress In-Line Inspection North Jersey Wanaqua Aqueduct

### Extra-High Resolution MFL In-Line Inspection of a finished water aqueduct mortar lined steel pipe with Lock-bar long seams

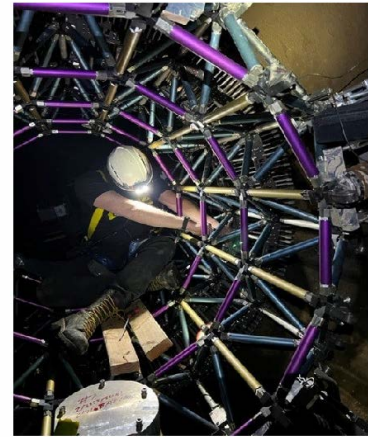
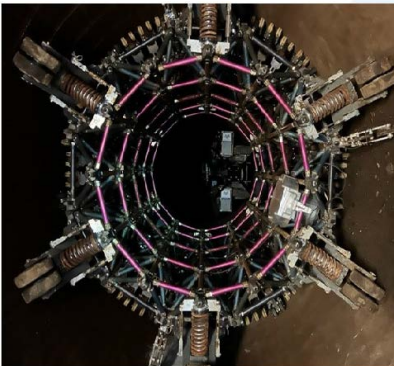
Following the site visit, Cypress personnel prepared the MFL tool for use in the 72" pipe. This process involved calibrating the sensors to account for the pipe's diameter, the thickness of the mortar lining, and the steel wall including the lock bar. Cypress performed the geometry inspection. After completing the geometry the tool's frame was reconfigured to the MFL inspection tool. Cypress' team then successfully completed the MFL inspection.
