# CYPRESS

Hetch Hetchy  
Regional Water System

## Steel Mortar-lined Pipeline Condition Assessment of 56 miles of 78" municipal water pipeline

Comprehensive Pipeline Integrity Management Project- Extra-High Resolution ("XHR") Magnetic Flux Leakage ("MFL") Inspection of City of San Francisco Public Utility ("SFPUC") Hetch Hetchy Water and Power ("HHWP") SJPL #3

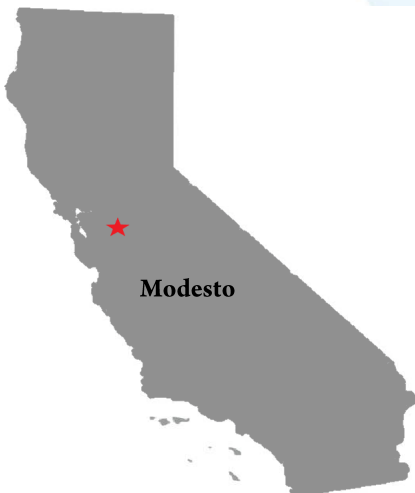
The HHWP SJPL3 pipeline was built in the mid-1970's. The only condition assessment performed on the line has been visual inspection either 1) by physically entering the line, or 2) by digging up a portion of the line and identifying defects in the exposed area. HHWP would then use this data to extrapolate the condition of the line. HHWP contracted with Cypress to inspect the steel pipe- line portion of SJPL3 using both the Geometry and MFL technologies.

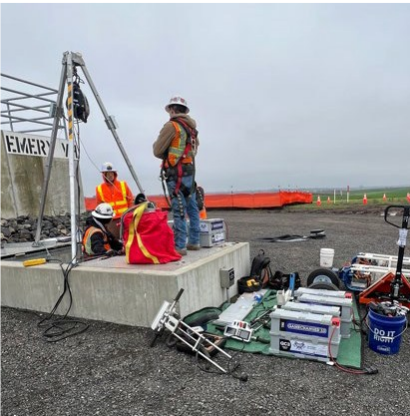
The project began with a site visit by Cypress personnel three months prior to the start of the inspection with the purpose of obtaining additional information which was not included in the "as- built" lay sheets. HHWP and Cypress visited a number of locations along the line that were not completely understood by reviewing the lay sheets. After the site visit, the Cypress personnel prepared the Geometry and MFL tools for use in the 78" pipe. The Cypress technology can be utilized to inspect pipelines ranging from 52" to 120" with its electric two vehicles. Smaller pipelines may be inspected with a tethered winching system. This Cypress technology is calibrated to the diameter of the line, the thickness of the mortar lining, and the thickness of the steel pipe wall.
